**Pacific Gas and  
Electric Company**

Docket No. 50-275, OL-DPR-80  
Diablo Canyon Unit 1  
Licensee Event Report 1-2000-004-01  
Unit 1 Unusual Event Due to a 12 kV Bus Fault

# LICENSEE EVENT REPORT (LER)

TITLE (4)  
**Unit 1 Unusual Event Due to a 12 kV Bus Fault**

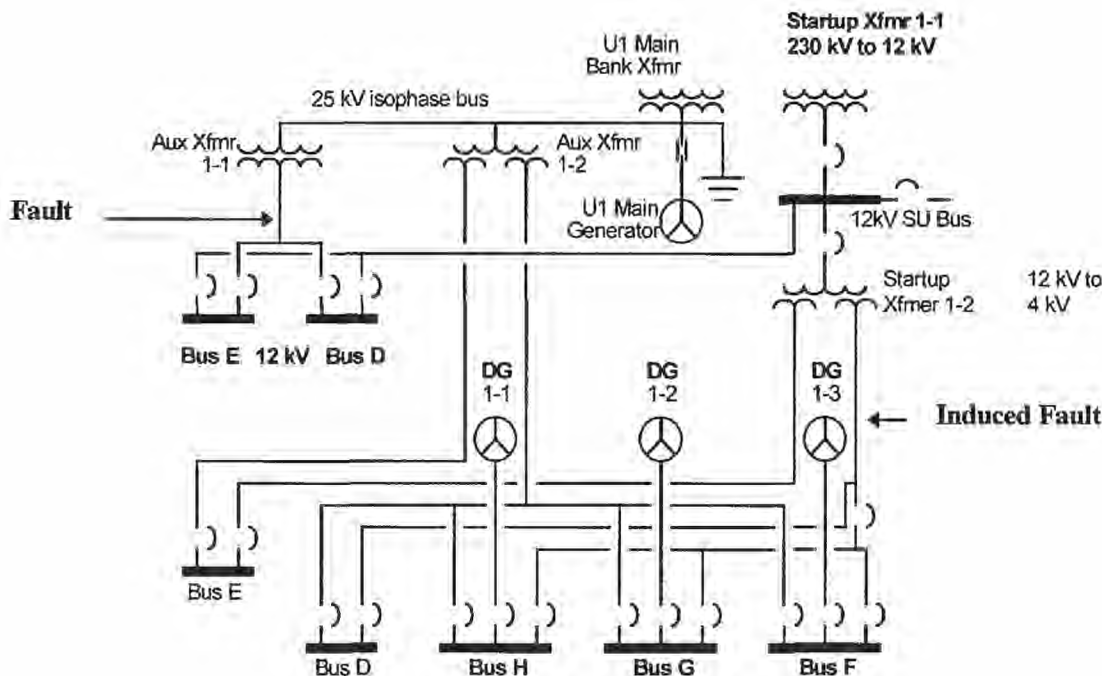
During normal operation, the Unit 1 main generator [EL] supplies 25 kV electrical power to the main transformers [XFMR] (25 kV to 500 kV) that are connected to the PG&E transmission system. The 25 kV system also supplies power to plant loads [EA] fed from Auxiliary Transformer 1-1 (25 kV to 12 kV) and Auxiliary Transformer 1-2 (25 kV to 4 kV). Figure 1 depicts a simplified single line diagram of the Unit 1 power supplies to the 4 kV and 12 kV buses.

On May 15, 2000, at 0025 PDT, a phase-to-phase fault occurred on the 12 kV nonsegregated phase bus between Auxiliary Transformer 1-1 and 12 kV bus D and bus E. The fault was immediately sensed by phase differential protective relays which initiated a unit trip. The unit trip caused a turbine trip and automatic reactor trip as designed. Power automatically transferred from Auxiliary to Startup power. Figure 1 shows the location of the fault.
